An Archaeological Curation-Needs Assessment for Headquarters Air Combat Command

Volume 1

7. PERFORMING ORGANIZATION NAME(S) AND ADDRESS(ES) U.S. Army Corps of Engineers, St. Louis District 1222 Spruce Street (CELMS-PD-C) St. Louis, Missouri 63103-2833			8. PERFORMING ORGANIZATION REPORT NUMBER Archaeological Curation-Needs Assessment Technical Report No. 10, Volume 1

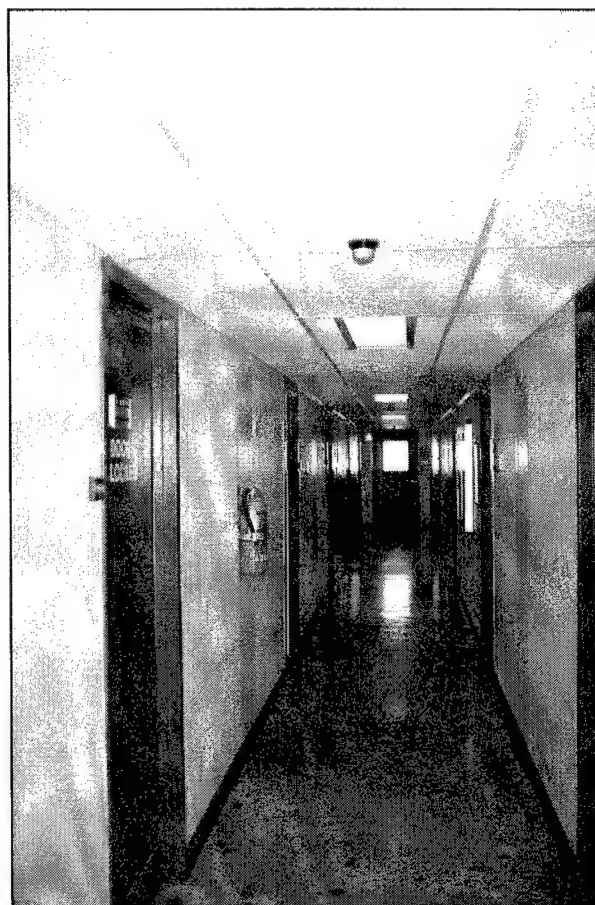
Figure 2. Fire extinguishers, fire doors, and fire walls in the hallway of Building 4300. The motion sensor on the ceiling may be nonfunctional.

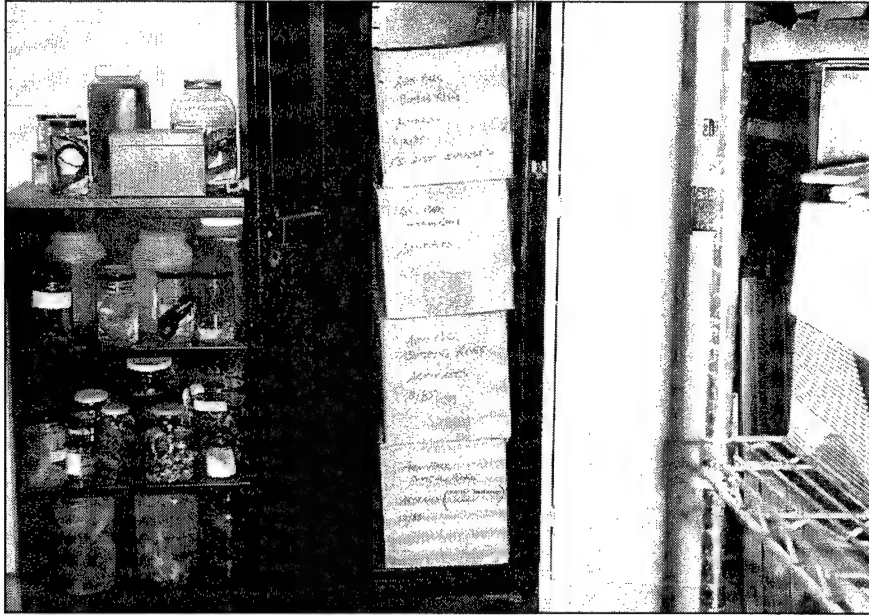
Primary containers consist of four boxes constructed of glued acidic cardboard with folded flap lids. Tape has been used to secure and reinforce the bottoms of the boxes, which measure 12.5 x 12 x 12 inches (l x w x h; approximately 1 ft³ each). Because of the way the boxes are stored, some have begun to show compression

Figure 21. The Avon Park AFR collection is stored in metal cabinets next to biological specimens. Note the damage to primary containers due to stacking.

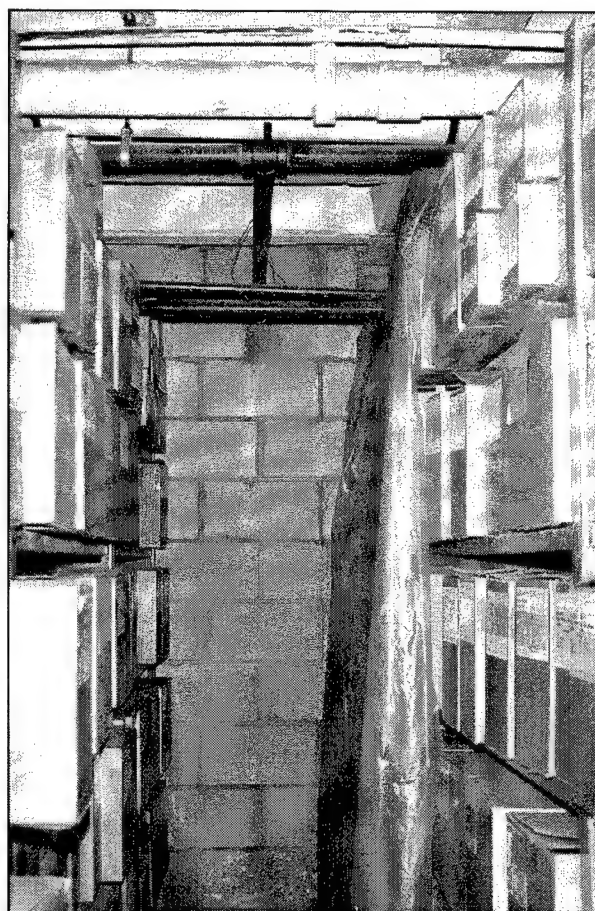
Figure 53. Plastic has been placed over the shelves and primary containers to prevent water damage from leaking overhead pipes.

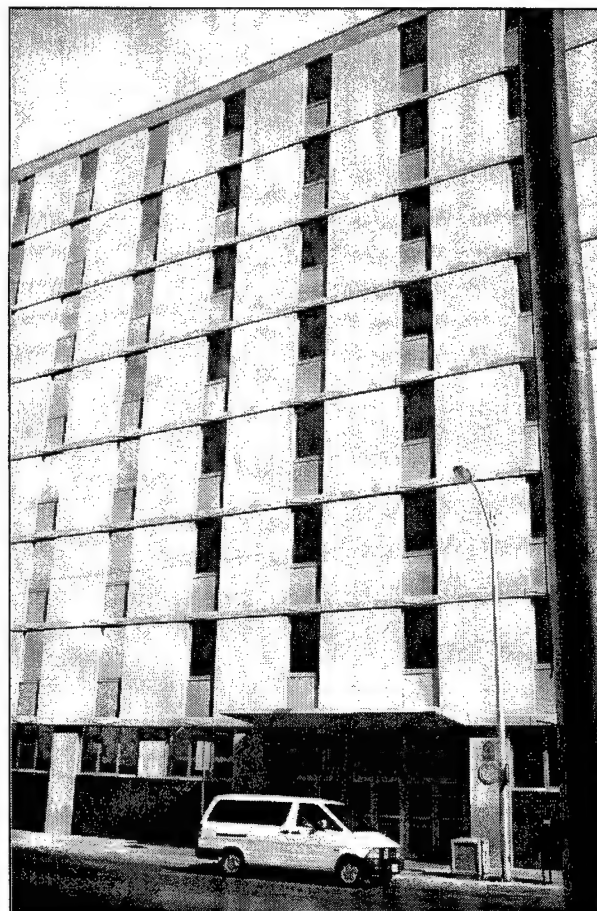
Figure 60. Exterior of the Federal Building in Albuquerque, which is considered structurally unsound.

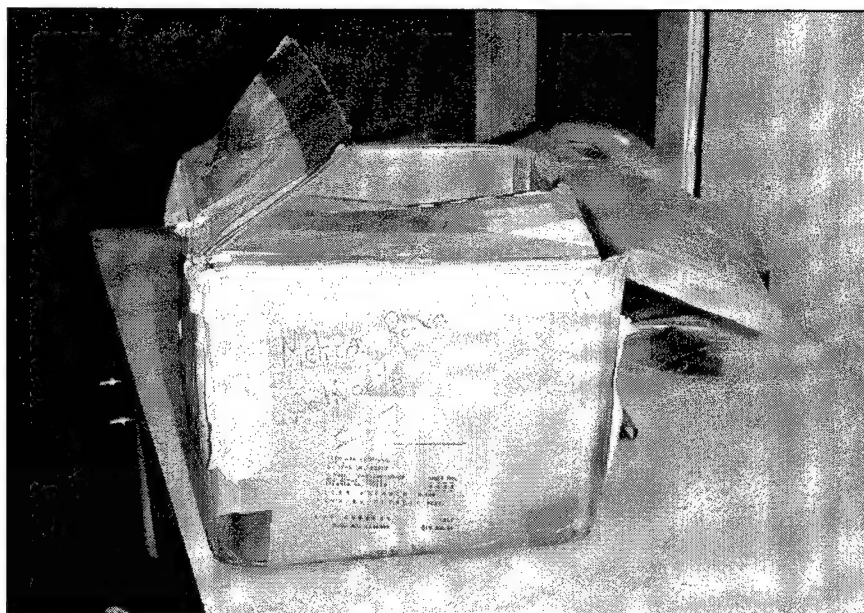
Figure 72. Damaged primary container housing Melrose AFR collection at the time of evaluation.

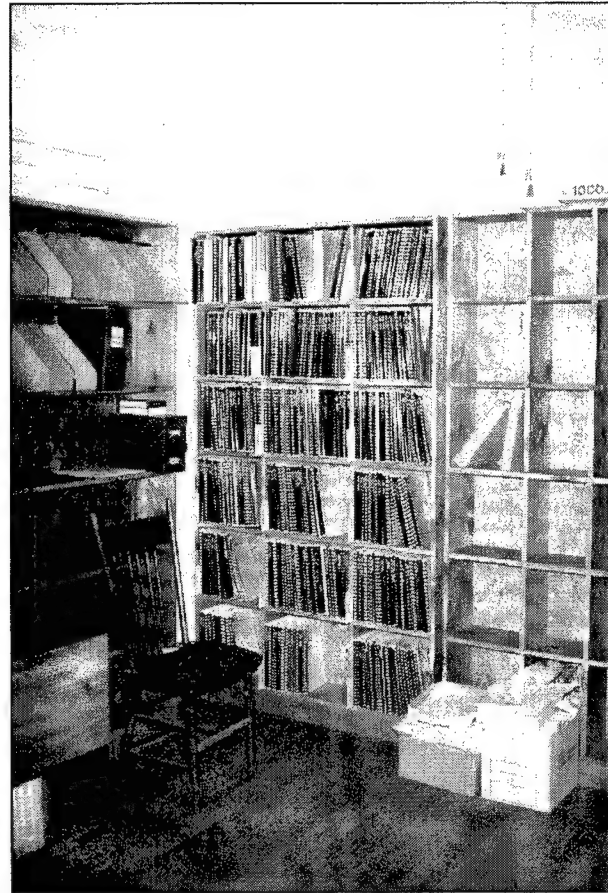
Figure 89. Documentation from investigations conducted on ACC installations is housed in acidic manila folders labeled in a variety of media.

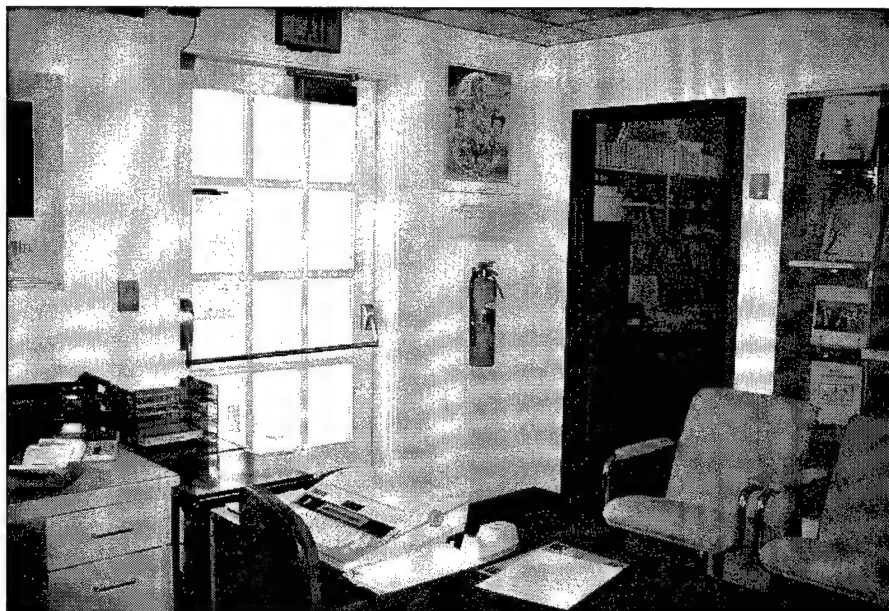
Figure 88. Contact-point intrusion alarms are installed on all doors leading to the exterior. Also note the fire alarm and extinguisher.
